**SAS Superstructure**

**Daily Diary Report by Bid Item**

Contract No.: 04-0120F4

Diary #: 184 Const Calendar Day: 814 Date: 01-Dec-2011 Thursday

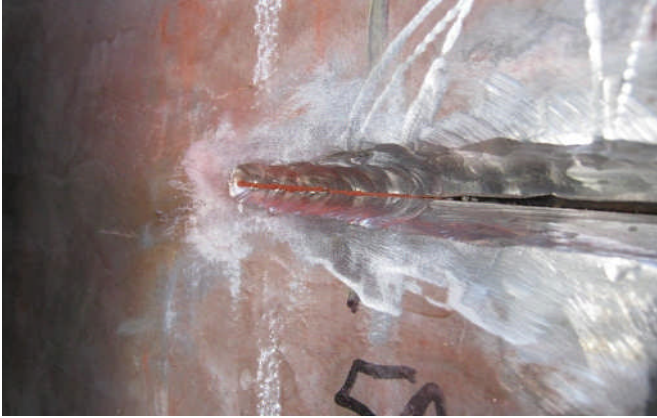
- On the left side of the excavation, the MT showed that the indication was visible up the side of the excavation to a depth of only 6mm from the surface. ABF Superintendent Scott Smith asked me if they had approval to weld, and I said no because the indication was not completely removed deep enough on the left side. He said that they would continue excavating to the left until the indication went away, or until they got as close to the concrete so as to still be able to perform the weld repair.

- They excavated to within about 30mm of the concrete, and the MT of the excavation showed the indication was visible up the side of the excavation to a depth of only 3mm from the surface (see attached photo). At this point, Scott Smith did not want to excavate any farther. The total length of the excavation is 375mm.

Excavation showing the open PJP root gap & the MT indication within 3mm of the surface

- At 11:50, ABF QC Manager Jim Bowers called me to discuss some possible options. He proposed that they weld the current excavation, and then wait to continue excavating and welding until after load transfer when the jacking frame will be pushed out about 1.6m and they would have easier access to the weld. I told him that I could not personally approve something like that, but would start some discussions with METS and Brian Boal.

- At 12:30, I called Brian Boal to give him an update.
- I received an email from Jim Bowers containing the updated request for weld repair detailing their proposal to weld this excavation, with a continuation of the excavation and weld after load transfer. METS is currently reviewing the request. I forwarded this email to Brian Boal, Alex Schmitt, and Roman Granados.

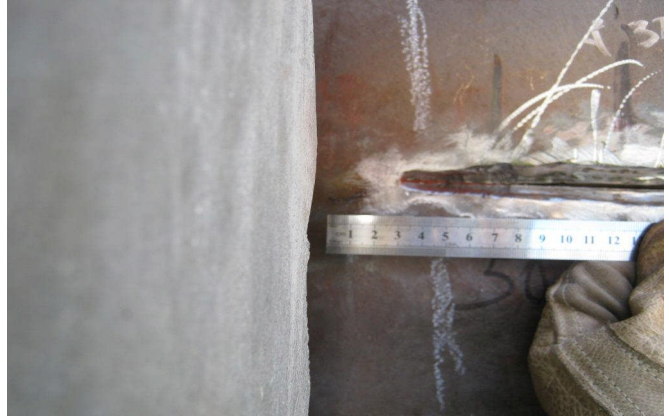
End of excavation near the edge of the W2 concrete
